FINAL INVESTIGATION REPORT

ACCIDENT OF M/S RAWALPINDI FLYING CLUB
CESSNA-172 AIRCRAFT REG NO. AP-BEJ AT
BENAZIR BHUTTO INTERNATIONAL AIRPORT
ISLAMABAD ON 1ST NOVEMBER, 2014

FINAL REPORT

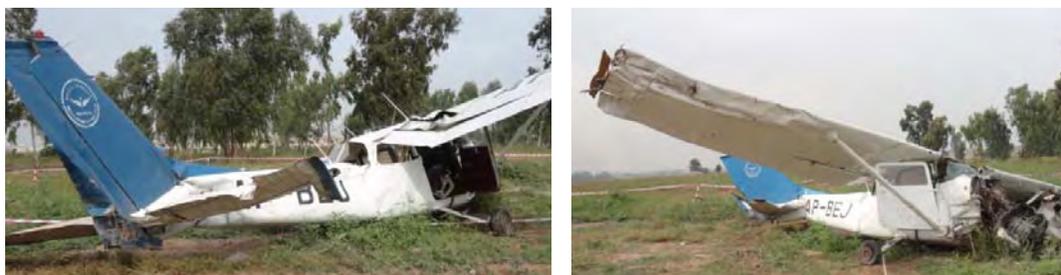
- 1.3. **Damage to Aircraft.** As a result of ground impact, wings, tail section, firewall and instrument panel were substantially damaged and distorted. Nose leg and propeller got separated from the aircraft. The engine mount got dislodged from its position.

Damage to the Aircraft
