## BUREAU OF AIRCRAFT SAFETY INVESTIGATION PAKISTAN

### FINAL INVESTIGATION REPORT

#### IN FLIGHT ENGINE NO 2 SHUT DOWN

| <b>Report Reference</b> | HQ BASIP/1000/434/Inv |

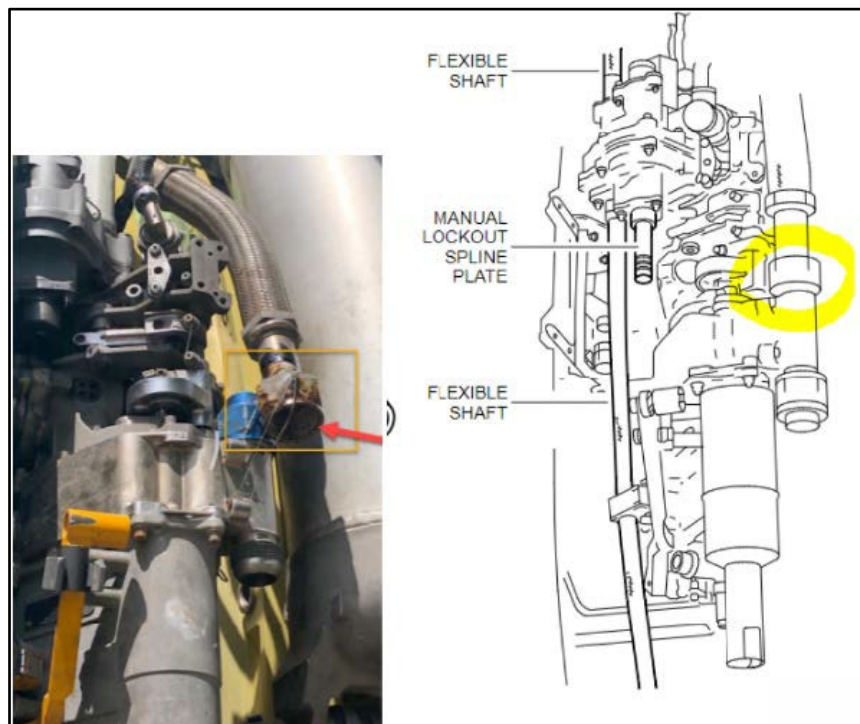
2.3.3.2. In the previous flight there was pilot reported defect of Thrust Reverser Unlock. The Thrust Reverser was deactivated as per AMM and put on MMEL by the maintenance crew. The MMEL maintenance procedure requests to install a dust cap on the flexible hose between the thrust reverser pressurization valve and the center drive unit, but, after the event flight, this cap was found missing. Which was further confirmed to be not installed and instead the hose end was wrapped with polythene using a tie wrap.

*Figure 1 Missing cap location on the flexible hose*

3.1.16. The absence of the MMEL-required blanking cap created an open pneumatic discharge path, allowing leaked hot bleed air to be released directly into the nacelle area adjacent to the ECU.

| 4.1.1.1. Use of standard blanking | |
|---|---|
| <b>Recommendation</b> | The operator should review and strengthen controls governing MMEL maintenance actions to ensure that all required parts, blanking devices, caps and associated materials specified in approved maintenance procedures are available and installed prior to aircraft release to service. |

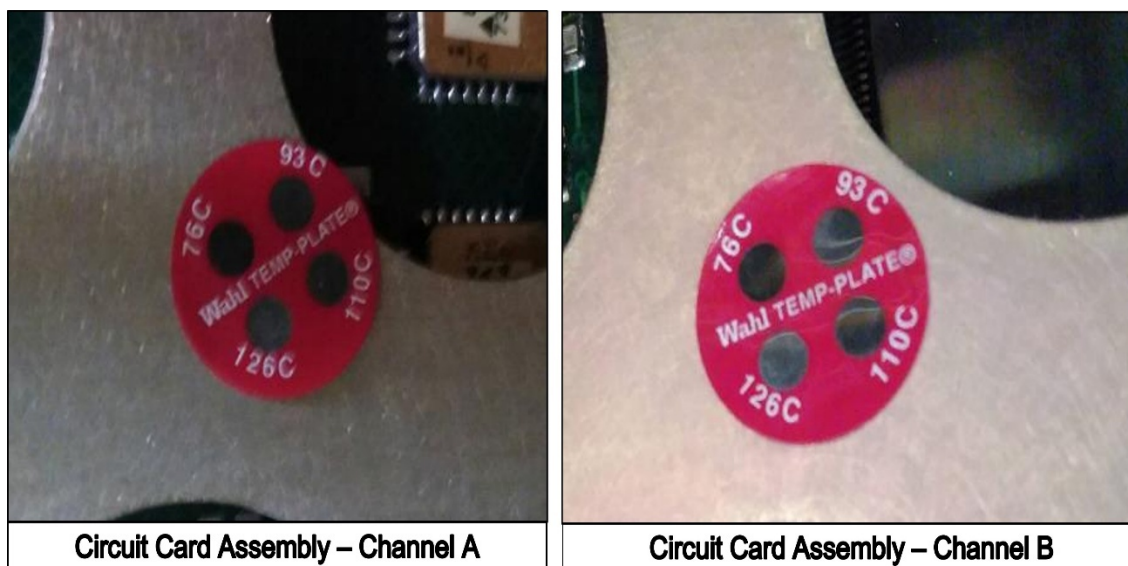
2.3.4.2. Both temperature recorder inside the ECU showed all fields dark, which means internal temperature was over 126°C. The ECU contains two temperature recorders on the plate between Channel-A and Channel-B Circuit Card Assemblies (CCAs). Each temperature recorder is divided into four sections, and each section has a different temperature threshold (76 °C, 93 °C, 110°C, and 126 °C). As each temperature threshold is reached, the temperature recorder section associated with that temperature threshold darkens. We found both temperature recorders dark on all four segments, which indicates that the internal ECU temperature was above 126 °C.

*Figure 2 Circuit Card Assembly*

2.3.4.3. The loss of both PSM is most likely caused by overheating of the ECU. The final temperature was above 126°C, which is outside the specified operating temperature range for electronic parts used in the ECU. As there are no indications that this extreme heat has been generated inside the ECU, therefore, there can only be an external cause for the over heat of the ECU.

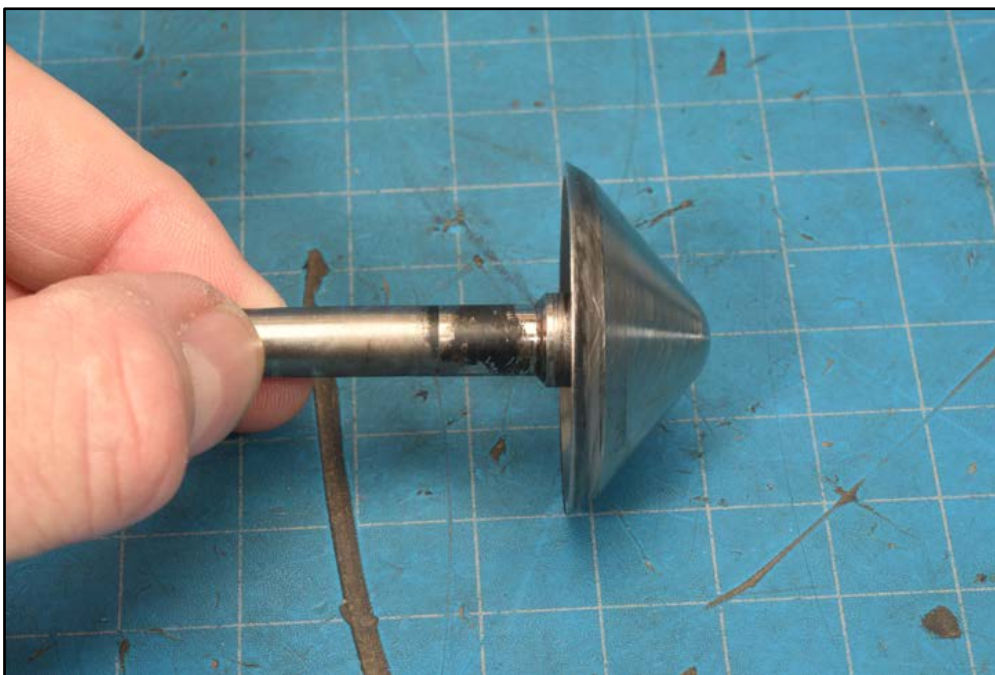
2.3.5.2. The examination revealed significant internal deterioration including; Severe galling of the flow housing and inlet assemblies, galling of multiple poppet assemblies, Grooving of stem poppets, Wear of sealing elements, Leakage of both regulator assemblies. These findings indicate degradation of internal valve sealing surfaces and pressure control components.

*Figure 3 Internal Deterioration*

3.1.14. Examination of the Engine No. 2 TRPV identified severe internal deterioration, including galling, grooving, seal wear and regulator leakage, which compromised the valve's ability to prevent bleed air leakage.

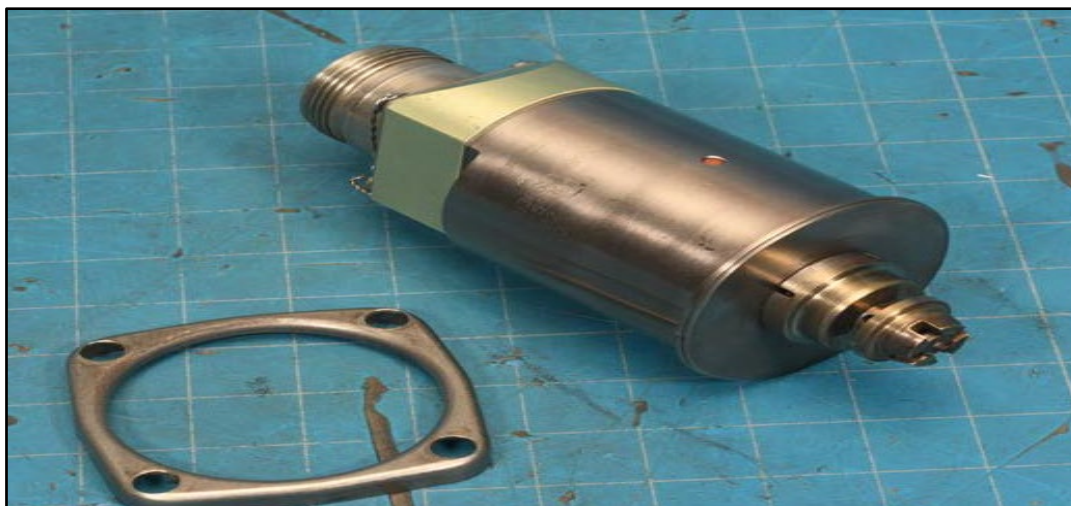
2.3.5.3. Although testing of the isolated solenoid valve assembly showed acceptable functional performance, the overall valve examination identified multiple mechanical defects capable of affecting the valve's ability to prevent unintended bleed air leakage. This resulted in continuous leakage of hot bleed air downstream of the valve subsequently increasing the temperature of the area and effecting the ECU.

*Figure 4 Solenoid Valve Assembly*
