FINAL INVESTIGATION REPORT

SERIOUS INCIDENT (TCAS – RA) REPORTED BY CHINA SOUTHERN AIRLINE FLIGHT CSN5237, BOEING 777-F1B AIRCRAFT, REG NO. B2072 (GUANGZHOU – RIYADH) ON 14TH MARCH, 2024

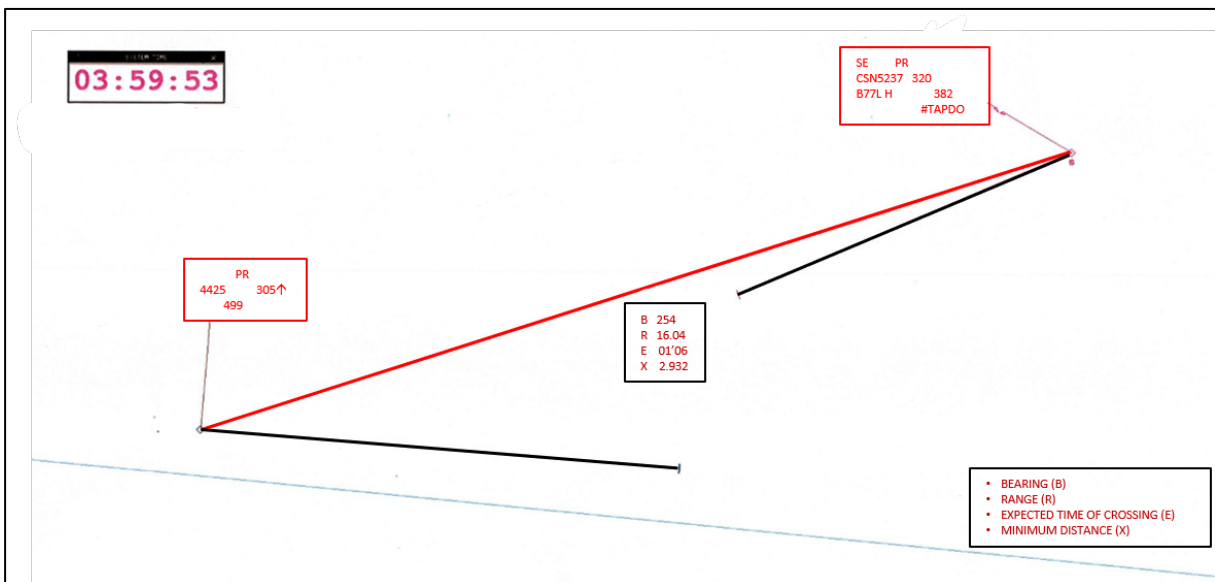
Figure 7 Military Traffic in Climbing Phase FL300 for Higher

2.1.8. At 03:59:53 h, Surveillance East Controller tried to pass traffic information observed on Radar Display to CSN5237 regarding fighter aircraft Squawking A4425 16 NM reciprocal to CSN5237 in climbing phase passing FL300 for higher.

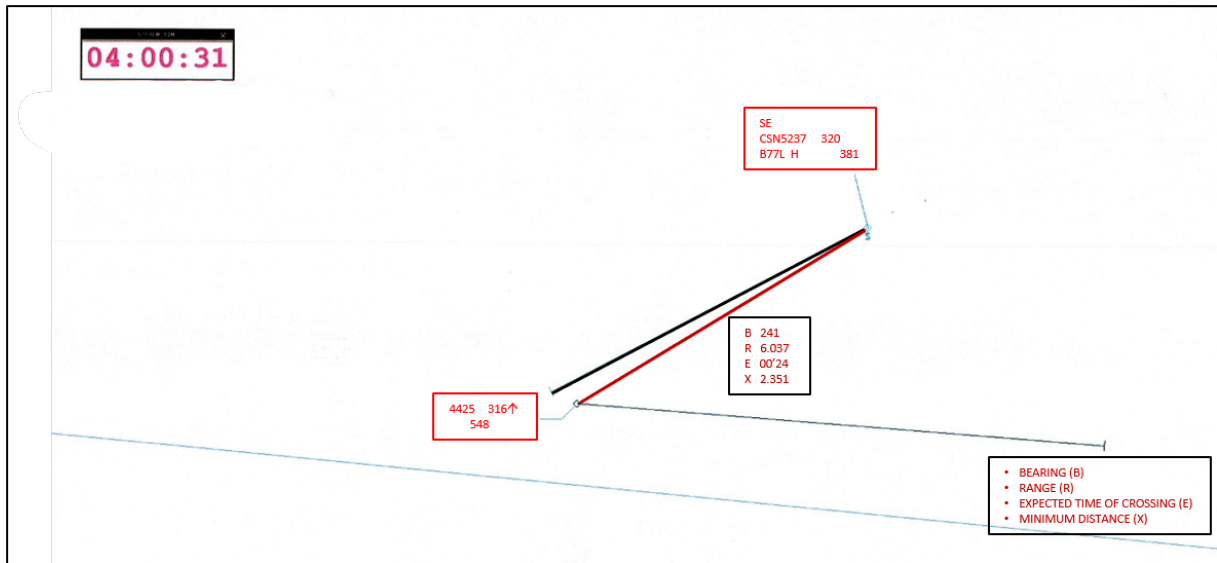
Figure 8 CSN5237 received TCAS-RA

2.1.9. At 04:00:31 h, CSN5237 expectedly received TCAS-RA due to fighter in climbing phase out of FL316.

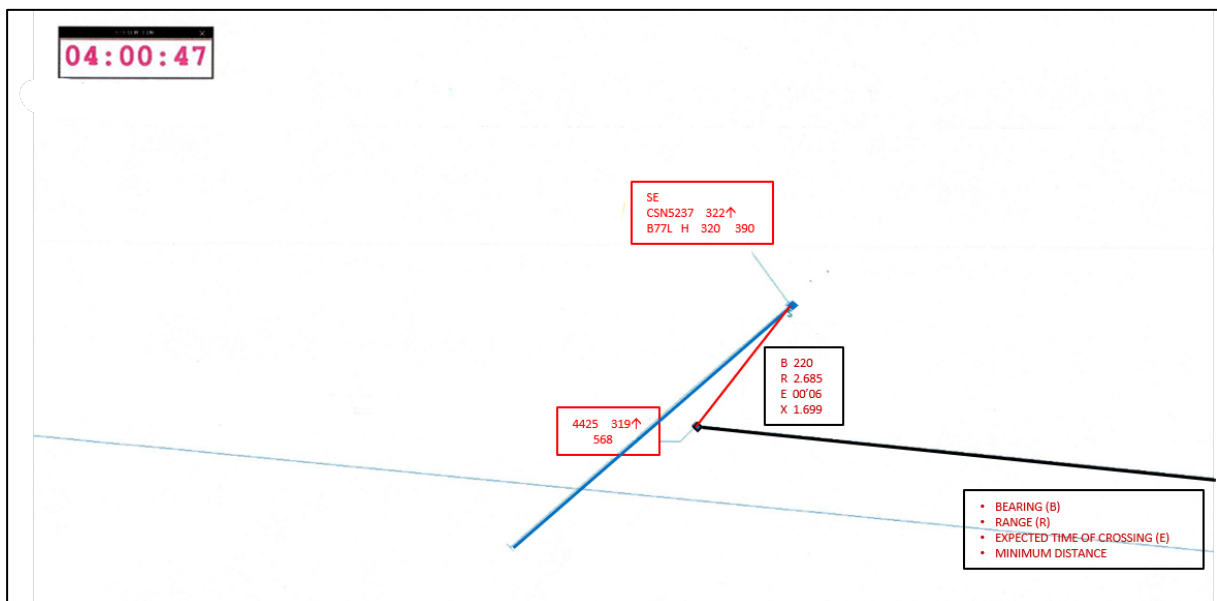
Figure 9 CSN5237 executed TCAS-RA Climb

2.1.10. At 04:00:47 h, as per Radar Screenshots CSN5237 executed TCAS-RA climb while fighter was still in climbing phase crossing FL319 at 2.6 NM.

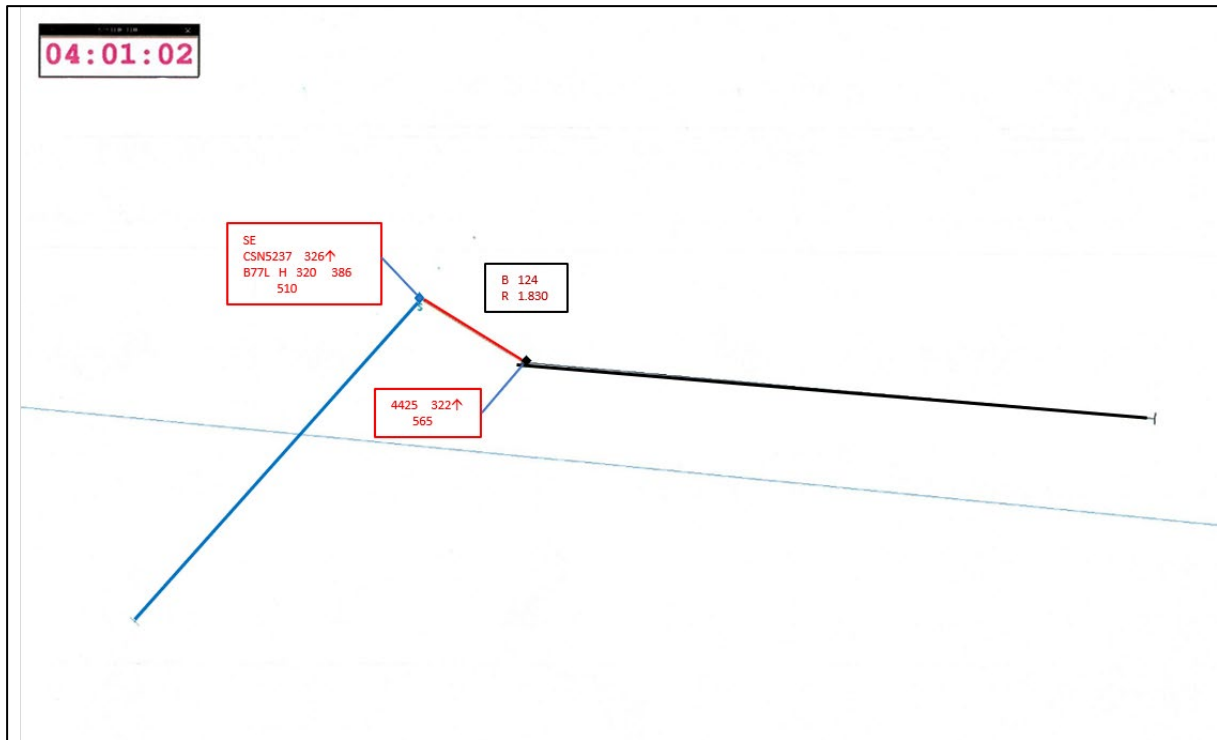
Figure 10 Fighters Climb up to FL322

2.1.11. At 04:01:02 h, military aircraft had climbed up to FL322 with separation of only 1.8 NM with CSN5237 which was climbing through FL326.

- 3.1.11. The PAF fighter aircraft violated the instruction to remain below FL300.
- 3.1.12. Problematic Direct Speech Circuit between ACC Karachi (East) and Bholari ATC contributed to the incident.

- 3.2.1.1. Unauthorized climb by PAF fighter aircraft beyond the restricted FL300.

4.1.1. Air Headquarters may ensure briefing on working of TCAS-RA for fighter aircrew.

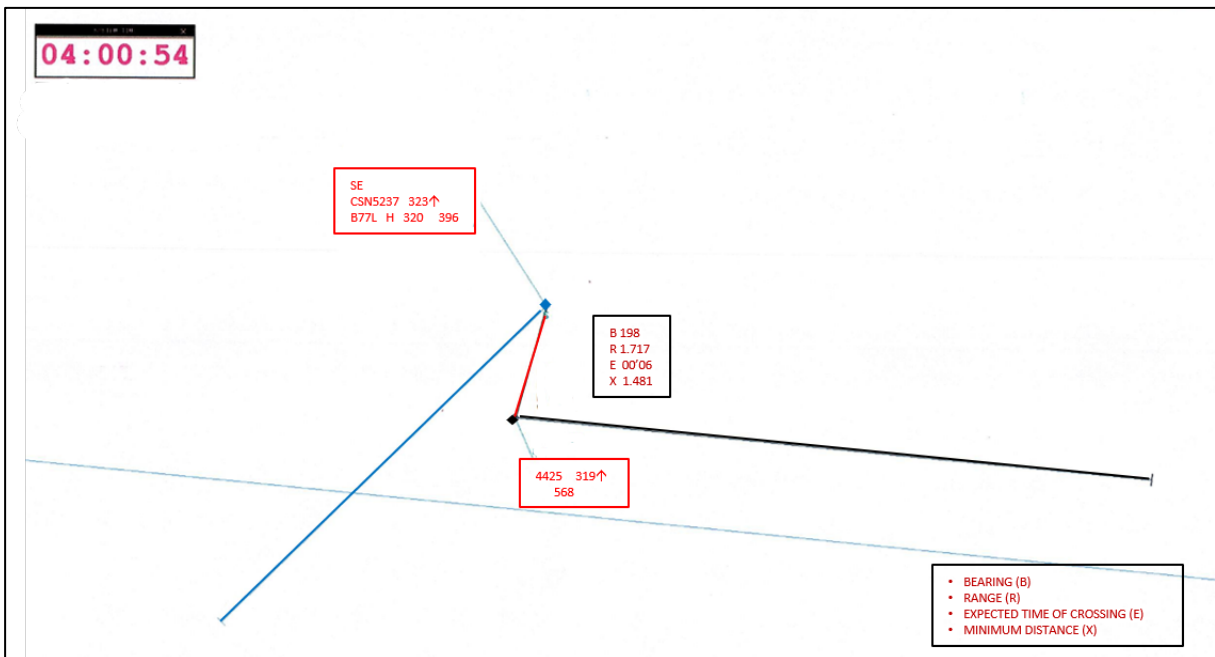
Figure 13 Vertical and Lateral Separation

2.1.14. The closest separation between both aircraft was 400 ft vertical and 1.7 NM lateral.
