FINAL INVESTIGATION REPORT

SERIOUS INCIDENT OF PAKISTAN INTERNATIONAL AIRLINES FLIGHT PIA 398 AIRBUS A320-214 AIRCRAFT REG. NO. AP-BLU AT SIALKOT INTERNATIONAL AIRPORT ON 12TH FEBRUARY, 2018

Dated: 28th March, 2023

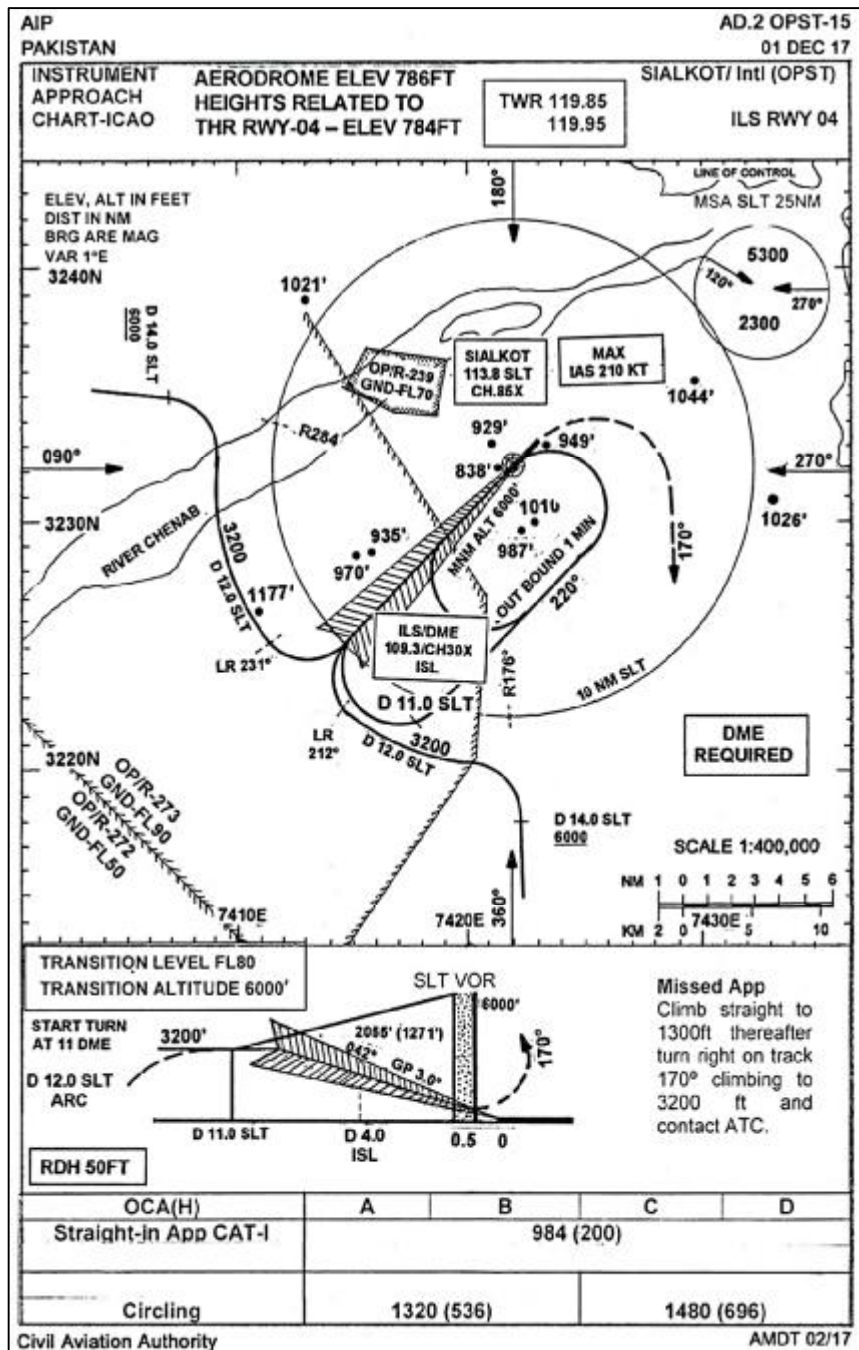
Figure 1 ILS Approach for R/W 04 SIAP, Sialkot

2.2.1. Once approaching SIAP, Sialkot, the aircraft was cleared for ILS Approach for R/W 04 at 23:27:00 and instructed to report once established on localizer as seen in figure below: -

2.2.2. During the Approach, the aircraft weather radar became unserviceable but was recovered once it was recycled. At 23:34:00 aircraft reported Going Around due to weather and expressed intentions for another attempt. The aircraft was cleared for circling Approach and cleared for climb to 3,000 ft. Aircraft subsequently requested clearance for 5,000 ft which was approved by SIAP Tower.
