FINAL INVESTIGATION REPORT

SERIOUS INCIDENT OF TCAS – RA REPORTED BY PAKISTAN INTERNATIONAL AIRLINES FLIGHT PIA 585, ATR 42-500 AIRCRAFT REG. NO. AP-BHP ON 15TH FEBRUARY, 2018

Dated: 30th March, 2023

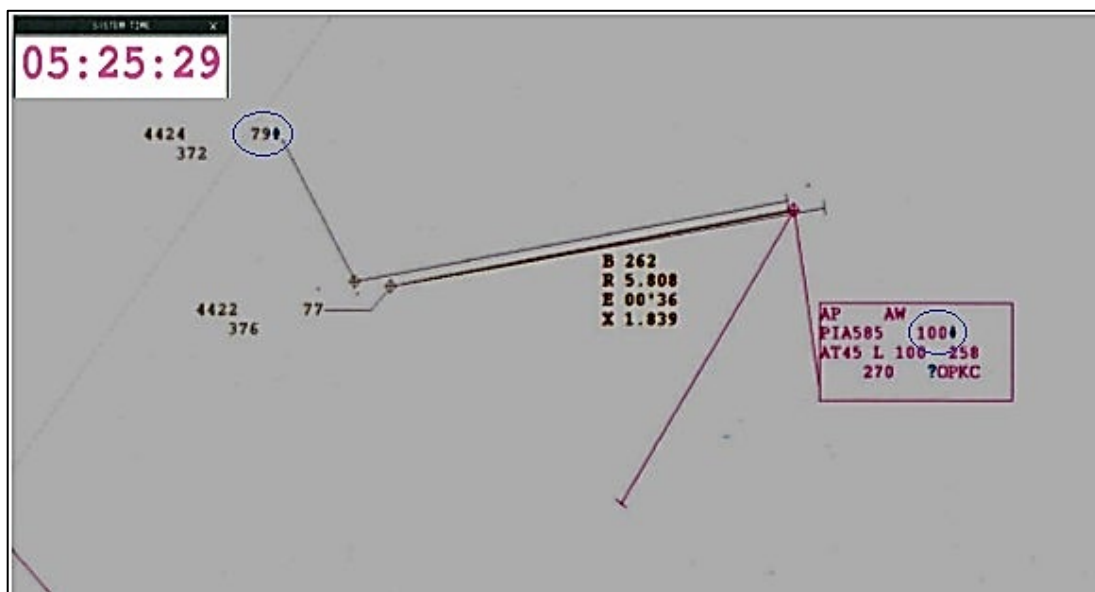
Figure 1 Radar Display Picture PIA 585 on FL100↓

1.1.6. At 05:25:29, Karachi Approach Radar display showed PIA 585 on a bearing of 082° to TIGER-1 and range was 5.8 NM. PIA 585 was showing FL100↓ and two out of three military aircraft showing their transponder FL77 and FL79↑.

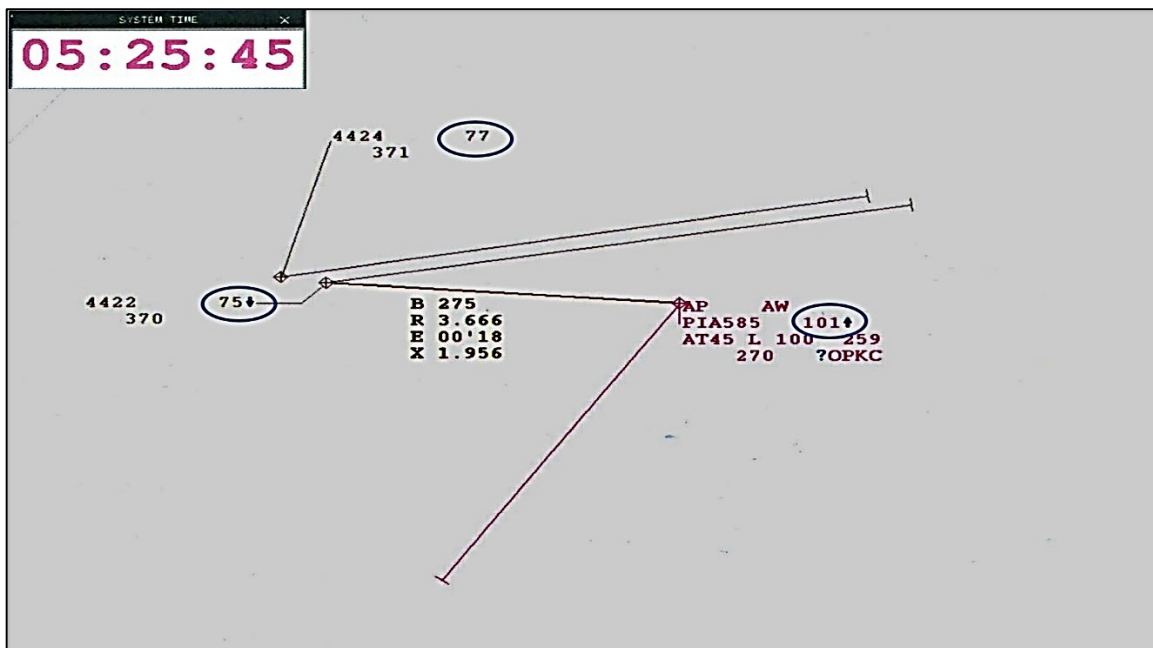
Figure 2 Radar Display Picture PIA 585 on FL101↑

1.1.7. At 05:25:45, Karachi Approach Radar display showed PIA 585 on a bearing of 095° to TIGER-1 and range was 3.6 NM. PIA 585 was showing climbed to FL101↑ and two out of three military aircraft showing their transponder FL77 and FL75↓.

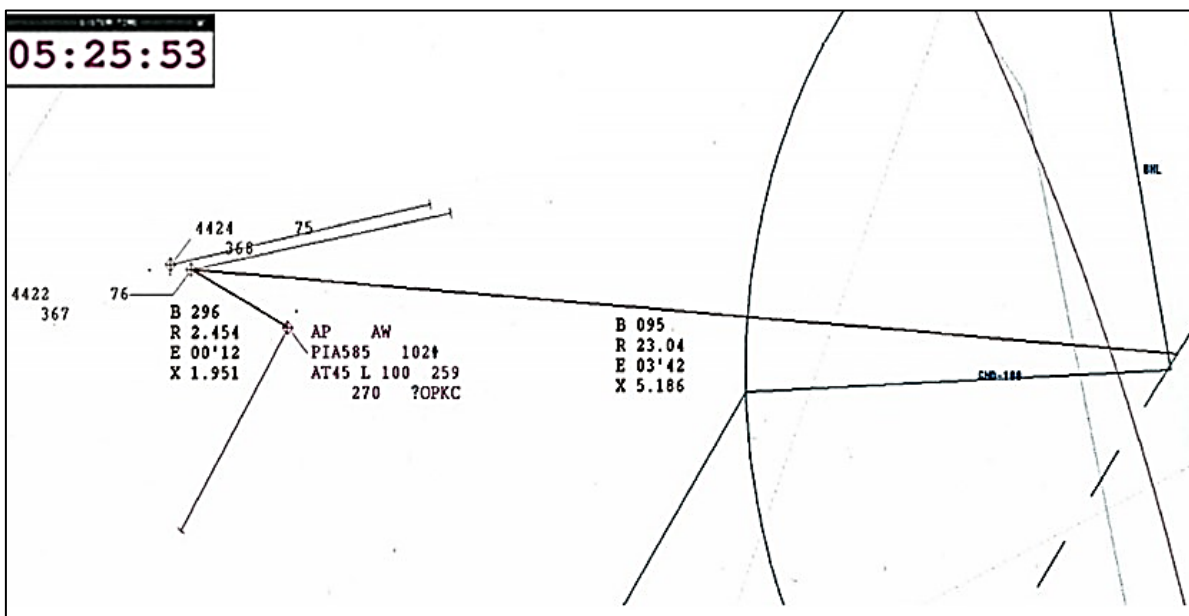
Figure 3 Radar Display Picture PIA 585 on FL102↑

1.1.9. At 05:25:53, Karachi Approach Radar display showed PIA 585 on a bearing of 116° to TIGER-1 and range was 2.45 NM. PIA 585 was showing climb to FL102↑ and two out of three military aircraft showing their transponder FL75 and FL76.
