## **FINAL INVESTIGATION REPORT**

### **SERIOUS INCIDENT (TCAS – RA) BETWEEN SAUDI AIRLINE FLIGHT SVA724, BOEING 777-368(ER) AIRCRAFT, REG. NO. HZ-AK11 & MILITARY AIRCRAFT SAPHIRE-24, BEECHCRAFT-350 AIRCRAFT, ON 21-03-2022**

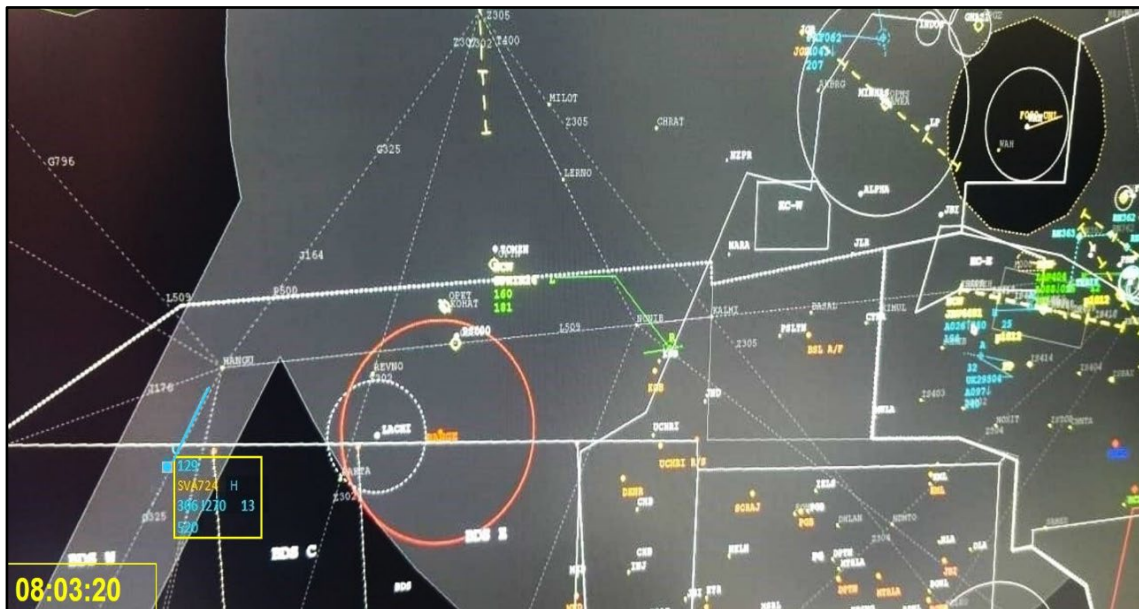
Figure 2 SVA724 came in contact with Cherat Approach

1.1.2. At 08:03:20 hours (h), SVA724 came in contact with Cherat Approach South and was given descent to FL170 along with STAR KALMI 1A route, ILS Approach for R/W 28L.

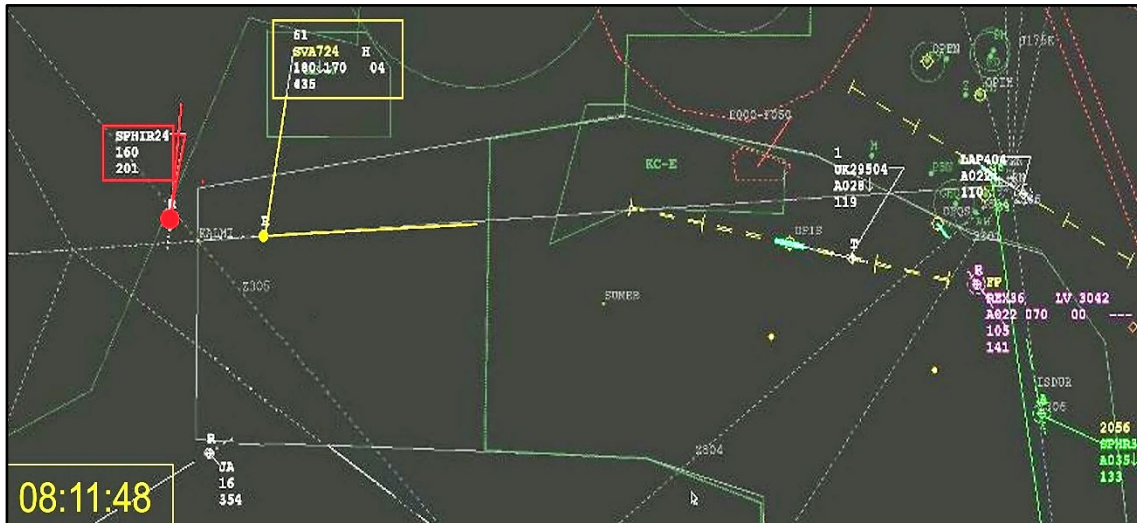
Figure 5 SVA724 started descent from FL181 to FL170.

1.1.10. At 08:11:48 h, SVA724 reported clear of conflict and descended from FL181 to FL170.

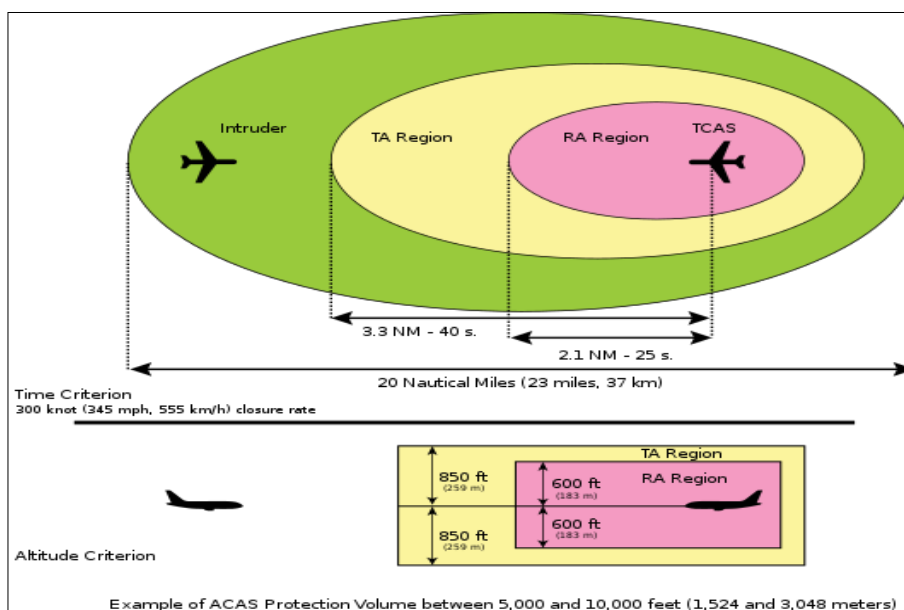
Figure 7 TCAS TA & RA ranges

1.18.2.6. **Warning Times** - In any potential collision, ACAS generates an RA nominally 15 to 35 seconds (s) before the Closest Point of Approach (CPA) of the aircraft. The ACAS equipment may generate a TA up to 20 s in advance of an RA. Warning times depend on Sensitivity Levels (SLs) of RAs.

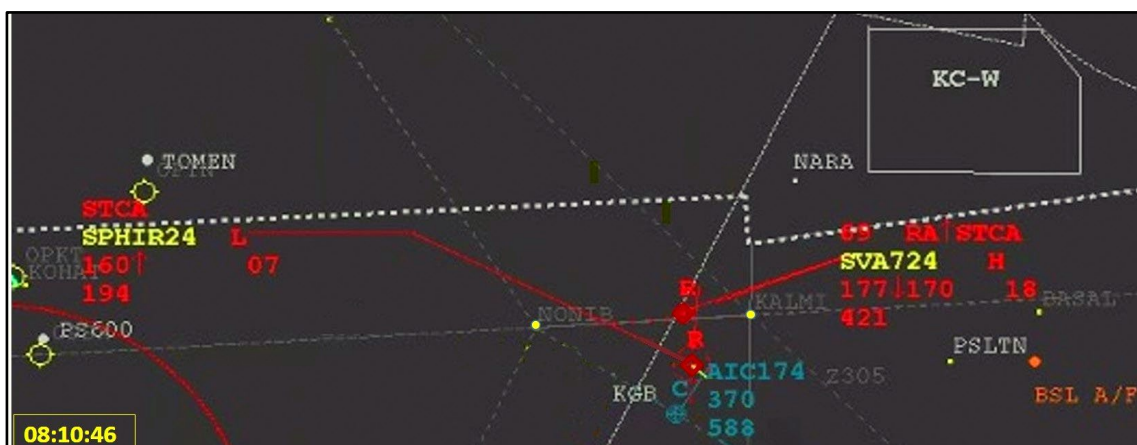
Figure 10 SVA724 crossing FL177 for FL170

2.1.8. At the time of RA, SVA724 was crossing FL177 for FL170 and SAPHIRE-24 was maintaining FL160 single level as depicted in Figure 10

2.1.11. At the time of activation of RA alert, SVA724 was maintaining ROD 1,800 ft which was contrary to ICAO Doc 8168<sup>6</sup>, Section 4, Chapter 3, Para 3.3 which states: -

- 3.2.1.1. Activation of TCAS – RA (**MAC – Mid Air Collision**) due to high Rate of Descent maintained by SVA724.
