FINAL INVESTIGATION REPORT

SERIOUS INCIDENT OF TCAS – RA AIRBLUE FLIGHT ABQ 200, AIRBUS 321 AIRCRAFT REG. NO. AP-BMW ON 29TH NOVEMBER, 2017

Dated: 30th March, 2023

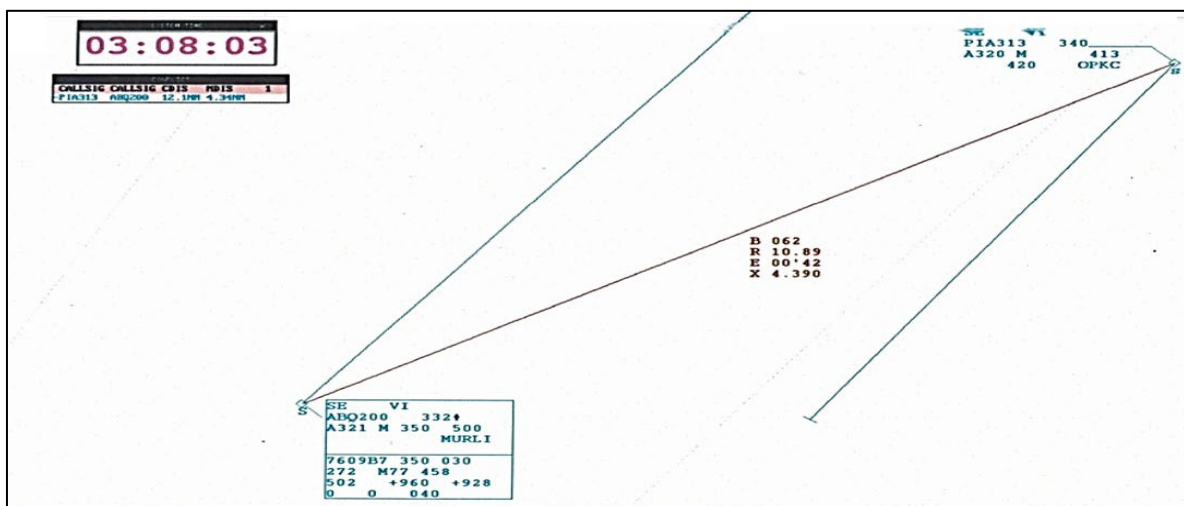
1.1.9. At 03:08:03, when both aircraft were 10.89 NM apart on parallel track, Air Traffic Management (ATM) System displayed Short Term Conflict Alert (STCA). On realizing the conflict ATC Karachi (Area Controller East) asked ABQ 200 to report heading for initiating radar vectors to enhance the spacing between two aircraft at 03:08:10. ABQ 200 in reply reported TCAS – RA.

Figure 1 Radar Display Picture showing STCA

2.1.7 The ATM system had shown STCA at 03:08:03, when both the aircraft were 10.89 NM apart on parallel track. Area Procedure Controller East responded on that and asked ABQ 200 to report heading. The intention was to give a radar heading for achieving the required standard separation. Simultaneously, ABQ 200 reported TCAS – RA (At that time both aircraft were approximately 7 NM on parallel track and ABQ 200 at FL335 and PIA 313 at FL340). Area Procedure Controller passed PIA 313 traffic information about ABQ 200. PIA 313 replied that they are visual with the traffic.

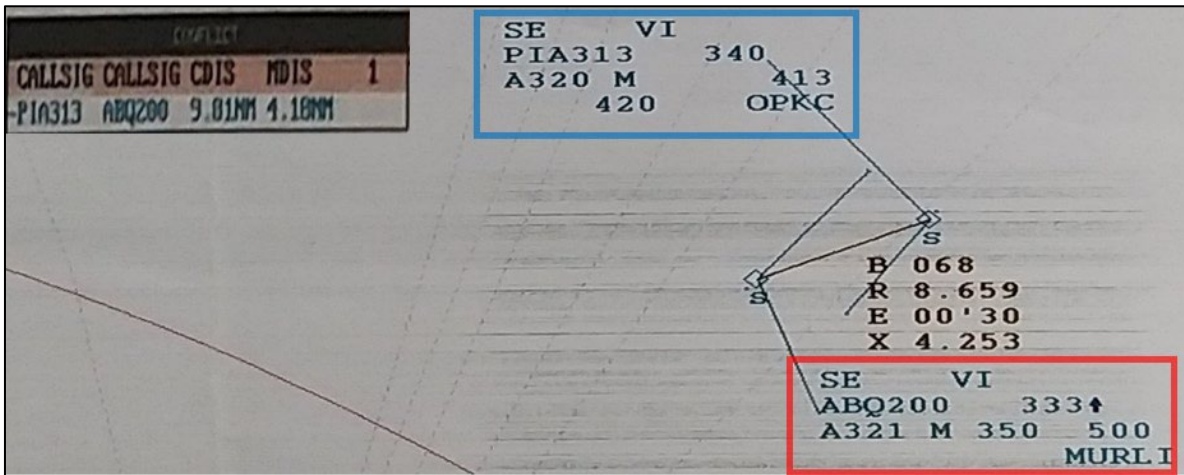
1.1.10. At 03:08:11, Radar Display Data shows that ABQ 200 in climbing phase passing FL333↑ and PIA 313 maintaining FL340. Both aircraft were 8.65 NM laterally apart on parallel track.

Figure 2 Radar Display Data of ABQ 200 on FL333↑

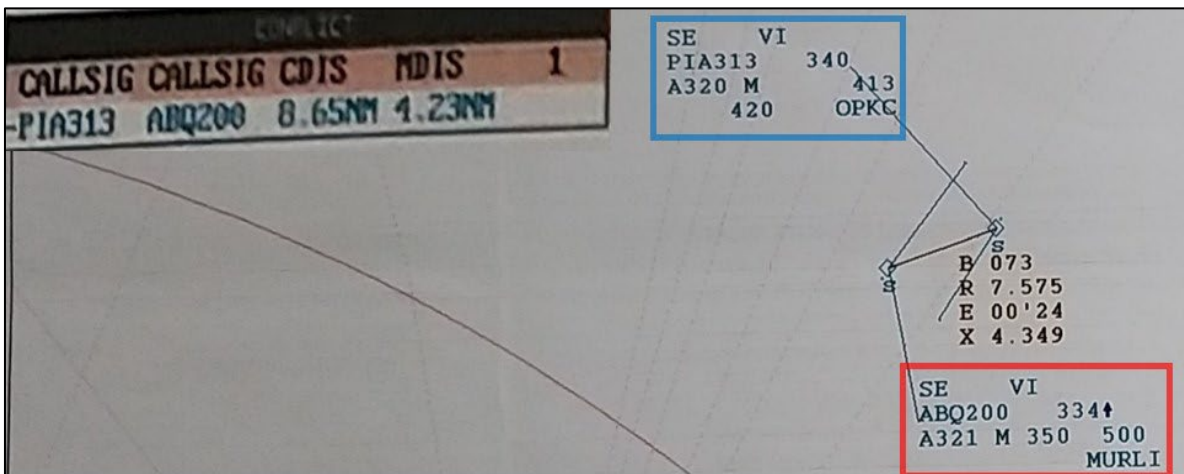
1.1.12. At 03:08:16, Radar Display Data shows that ABQ 200 in climbing phase passing FL334↑ and PIA 313 maintaining FL340. Both aircraft were 7.57 NM laterally apart on parallel track.

Figure 3 Radar Display Data ABQ 200 FL334↑

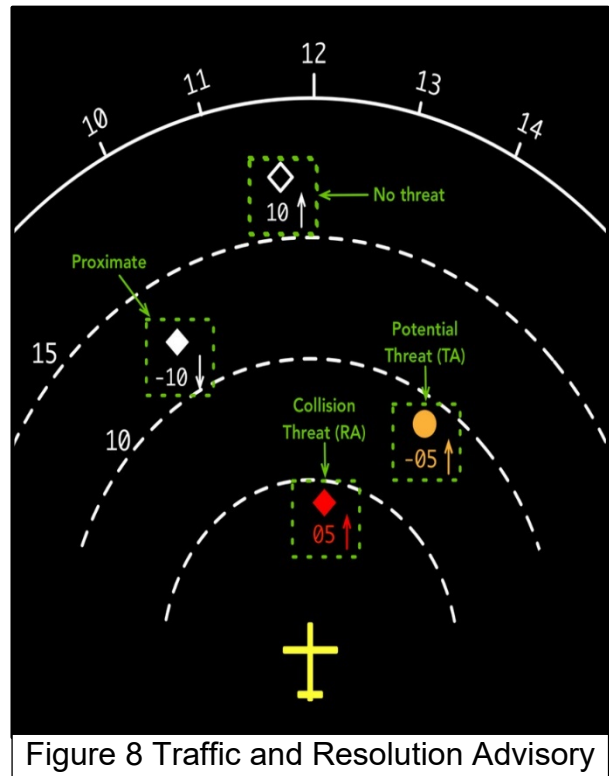
1.16.1.4. **Traffic Advisories (TAs)** - TAs alert the flight crew to potential RAs and may indicate the range, range rate, altitude, altitude rate and bearing of the intruding aircraft relative to own aircraft. TAs without altitude information may also be provided on Mode 'C' or Mode 'S' equipped aircraft that have temporarily lost their automatic altitude-reporting capability. The information conveyed in TAs is intended to assist the flight crew in sighting nearby traffic.

1.16.1.5. **Resolution Advisories (RAs)** - If the threat detection logic in the ACAS computer determines that an encounter with a nearby aircraft could soon lead to a near-collision or collision, the computer threat resolution logic determines an appropriate vertical manoeuvre that will ensure the safe vertical separation of the two aircraft. The selected manoeuvres ensure adequate vertical separation within constraints imposed by the climb rate capability and proximity to the ground of the two aircraft.

1.16.1.6. The RAs provided to pilot can be divided into two categories: corrective advisories, which instruct pilot to deviate from the current flight path ("CLIMB" when aircraft is in level flight); and preventive advisories, which advise the pilot to maintain or avoid certain vertical speeds ("DON'T CLIMB" when aircraft is in level flight).

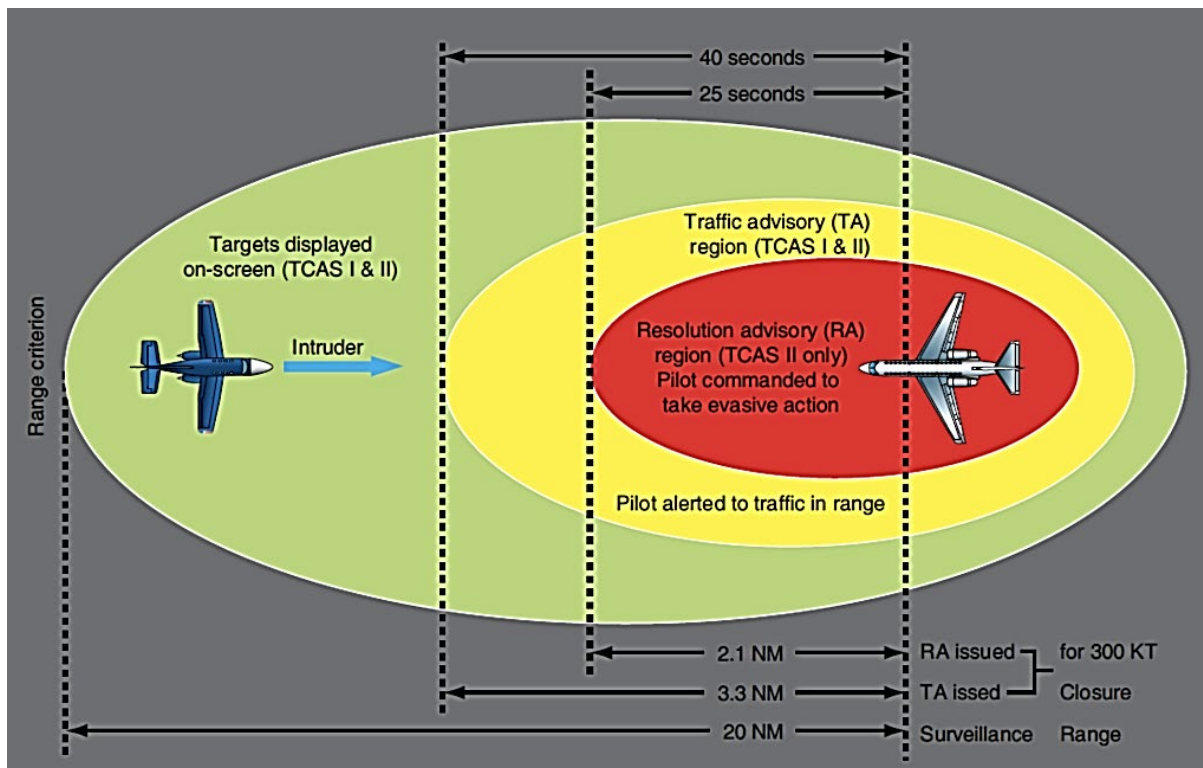
1.16.1.7. **Warning Times** - In any potential collision, ACAS generates an RA nominally 15 to 35 seconds (s) before the Closest Point of Approach (CPA) of the aircraft. The ACAS equipment may generate a TA up to 20 s in advance of an RA. Warning times depend on Sensitivity Levels (SLs) of RAs.

Figure 9 TA and RA ranges

3.1.9 Further ICAO Doc 9863 section 4.1.2.1 describes Horizontal distance thresholds for RA which is 1.1 NM above FL200, whereas both aircraft crossed each other at about 4.4 NM. PIA 313 received TA which also show that ABQ 200 might have received erroneous RA.
