FINAL INVESTIGATION REPORT

SERIOUS INCIDENT (TCAS – RA) REPORTED BY CHINA SOUTHERN AIRLINE FLIGHT CSN5237, BOEING 777-F1B AIRCRAFT, REG NO. B2072 (GUANGZHOU – RIYADH) ON 14TH MARCH, 2024

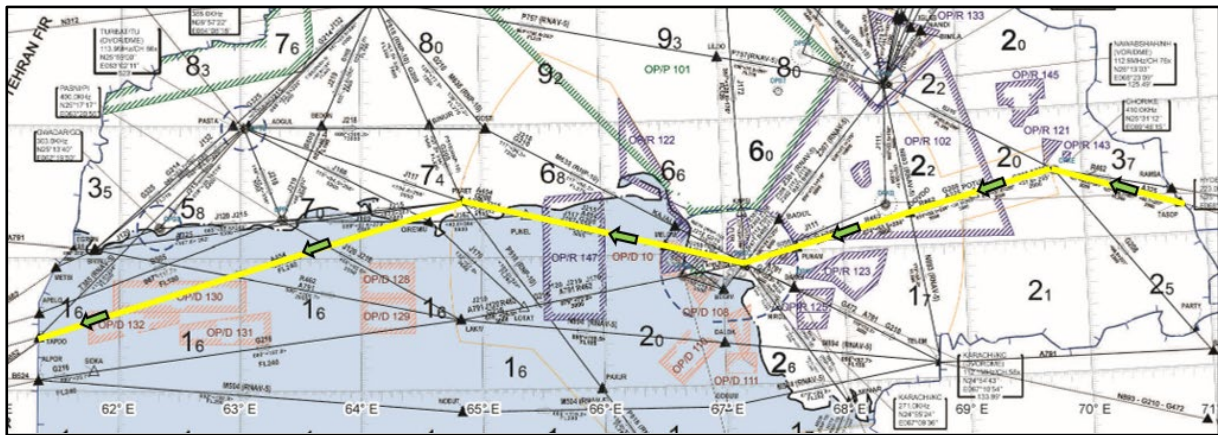
Figure 1 CSN5237 Route

1.1.1. On 14th March, 2024, China Southern Airline flight CSN5237, Boeing 777-F1B aircraft, Reg. No. B-2072 was operating from ZGGG, Guangzhou, China to OERK, Riyadh, Saudi Arabia on ATS Route A325 TASOP-KE-KC- PARET-TAPDO.

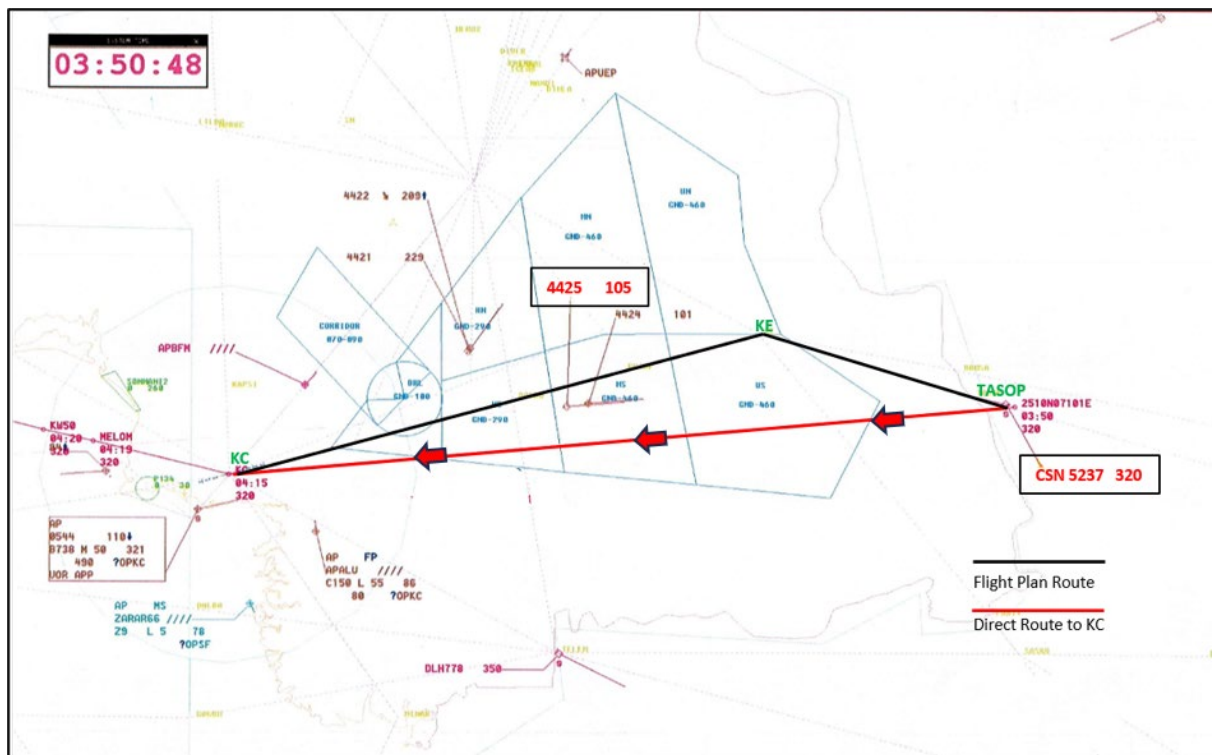
Figure 5 CSN5237 at position TASOP

2.1.6. At 03:50:55 h, CSN5237 checked position TASOP maintaining FL320 and was given direct routing to Karachi by East Surveillance Controller.

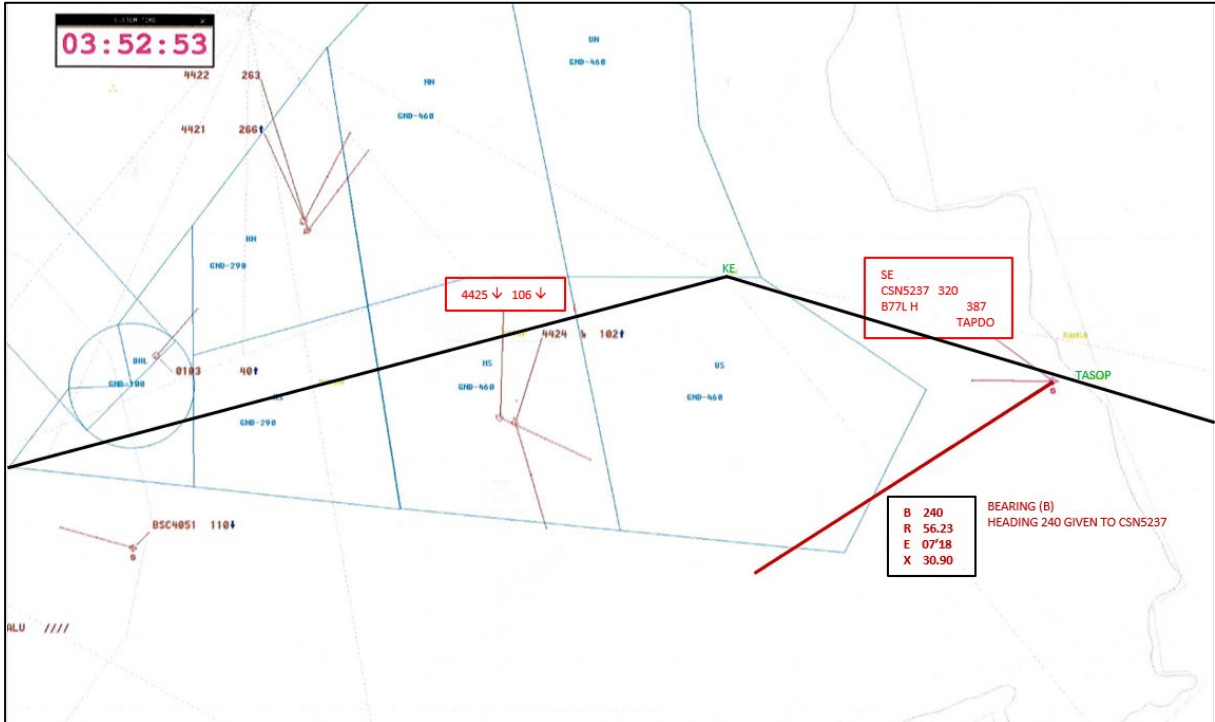
Figure 6 CSN5237 taken on Vectors to bypass Bholari Training Area

2.1.7. At 03:52:48 h, when CSN5237 was 38 Nautical Miles (NM) South East of KE, it was taken on vectors towards South-West by East Surveillance Controller to bypass “Uniform South Area” and other Bholari training areas in which PAF fighters were operating at and below FL400.

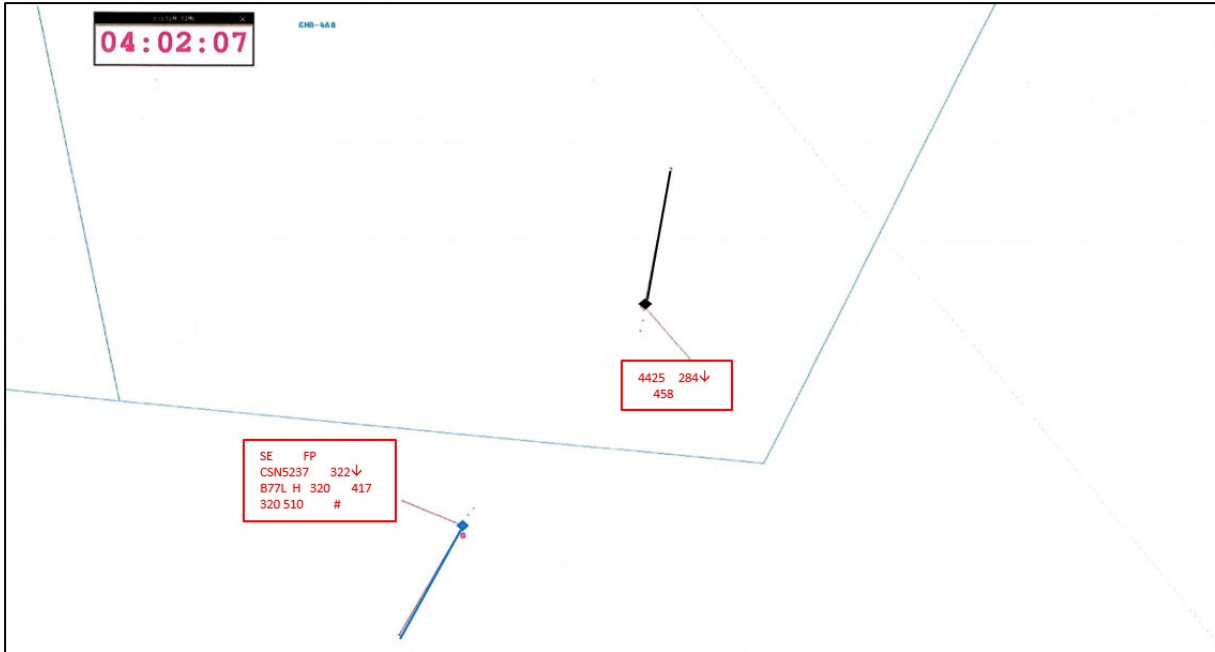
Figure 12 CSN5237 descending back to FL320

2.1.13. At 04:01:39 h, CSN5237 again reported that it had climbed to FL330 due to TCAS-RA manoeuvre and was now back to FL320.

2.1.14. The closest separation between both aircraft was 400 ft vertical and 1.7 NM lateral.
